No.		1/2
N°	AL-2003-01	
Date	2003-01-09

## SERVICE DIFFICULTY ALERT

### BOMBARDIER (CANADAIR) CL600 CHALLENGER AND RJ 100 SERIES

#### AILERON QUADRANT / FEEL UNIT P/N 600-91178-7

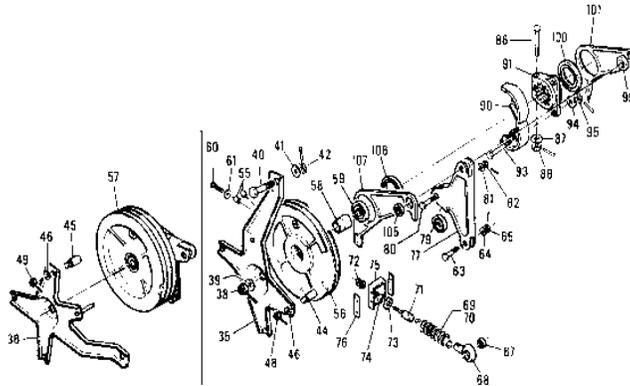
While performing a 600-hour inspection and after completing operational tests on the aileron system, personnel were exercising the ailerons bleeding off the hydraulic system pressure. When the pressure was released, a loud bang was heard while the controls were being moved. Troubleshooting to find the source started, and when the aileron controls were moved again, the bang was heard and the wheel well quadrant area was determined to be source of the noise. The quadrant was removed and disassembled. Quadrant bearing, P/N MS 27646-39 was found dry of grease and the balls had worn a groove deep into the inner race.

It is important to note the operator did not experience any symptoms that would have lead to the discovery of this failing part prior to its failure, i.e. stiff or ratcheting control wheel. This quadrant has a common part number throughout the Challenger and Regional Jet 100 fleet.

Transport Canada strongly recommends that an operational check be carried out on the aileron system similar to the text above. A visual inspection of the quadrant to ensure the presence of sufficient lubrication should be carried out at the operator's earliest convenience. If left undetected, aileron control operation could be compromised, possibly resulting in jamming or aileron control stiffness.
